Fabled Copper Secures Underground Adits

Vancouver, British Columbia – Fabled Copper Corp. (“Fabled Copper” or the “Company”) (CSE: FABL; FSE: XZ7) announces that from mid-June – Early September 2022 they were successful in securing 4 adit entrances on its Muskwa Copper Project. See Figure 1 below.

The first of the 4 adits worked on was the Davis Keays Eagle Vein 6400 level, followed by the Eagle Vein 5950 level, the 5800 level of the Harris vein and then the final adit for the season, the Magnum 5200 level.

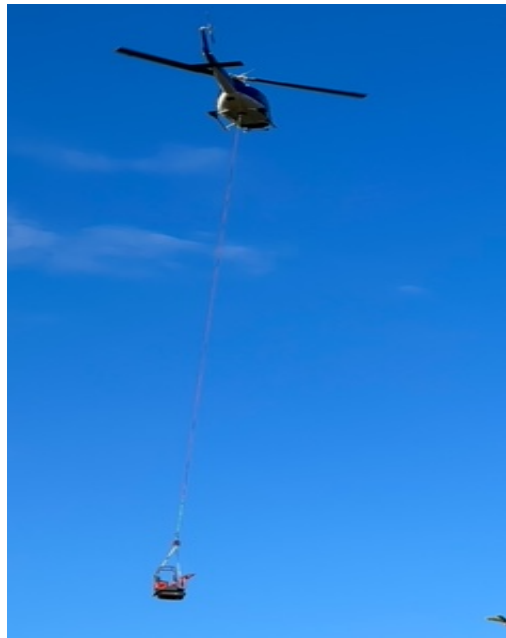
A 1 tonne mini-excavator was slung into and moved around by a 205 helicopter during the moves. See Photo 1 below.

Photo 1 – Excavator Move by Helicopter

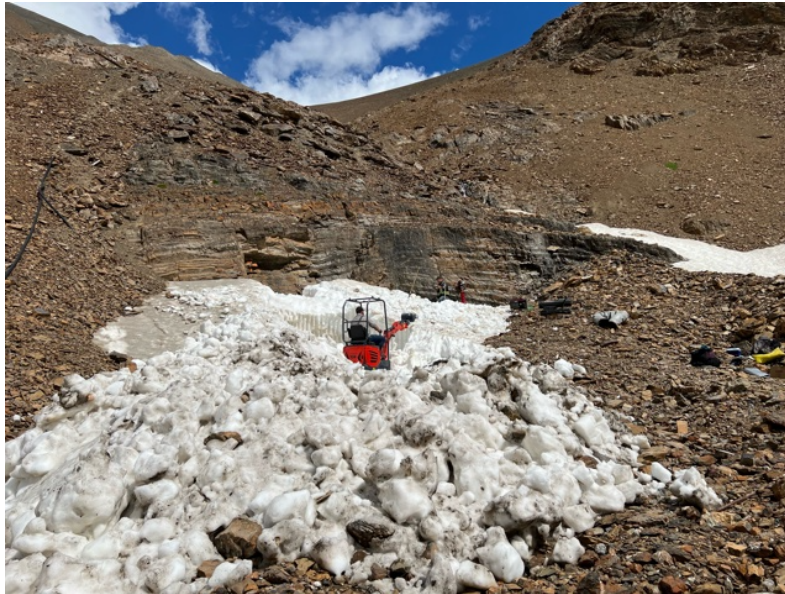
The initial snow clearing began in mid-June as at the 6,400-foot elevation the spring melt had not begun at that time. See Photo 2 below.

Photo 2 – 6400 Level Snow Removal.

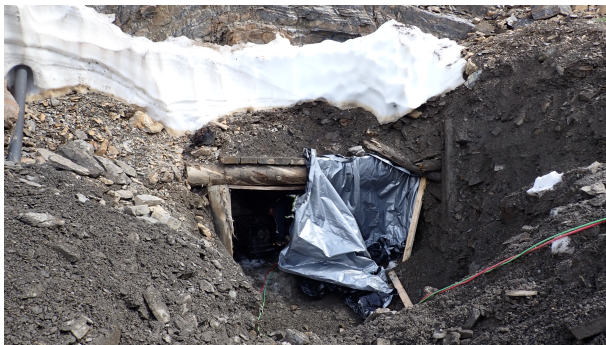
Photo 3 – Cleaning 6400 level adit

Once all the snow was removed from all exposed rock faces including the back or the roof of the entrance of the adit, all were then mechanically scraped to remove all loose debris that could pose a safety hazard and two munster heaters were placed in the entrance to melt the ice plug. See Photos 3-4 below.

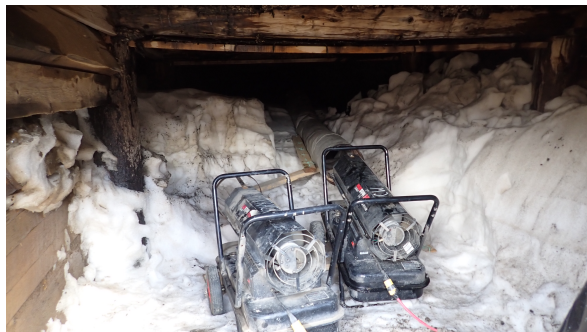
Photo 4 – Heaters in Entrance

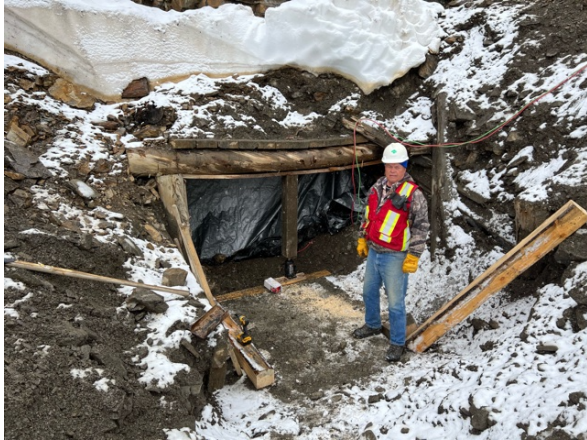
Photo 5 – Base Being Constructed

While the ice plug was thawing out, the base at the entrance was constructed and a tower built to clear future snow falls and a door with lock installed, see Photo's 5,6 and 7 below.

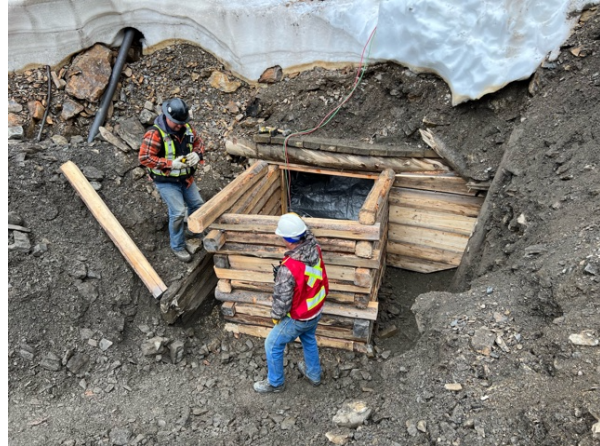
Photo 6 – Tower Being Constructed

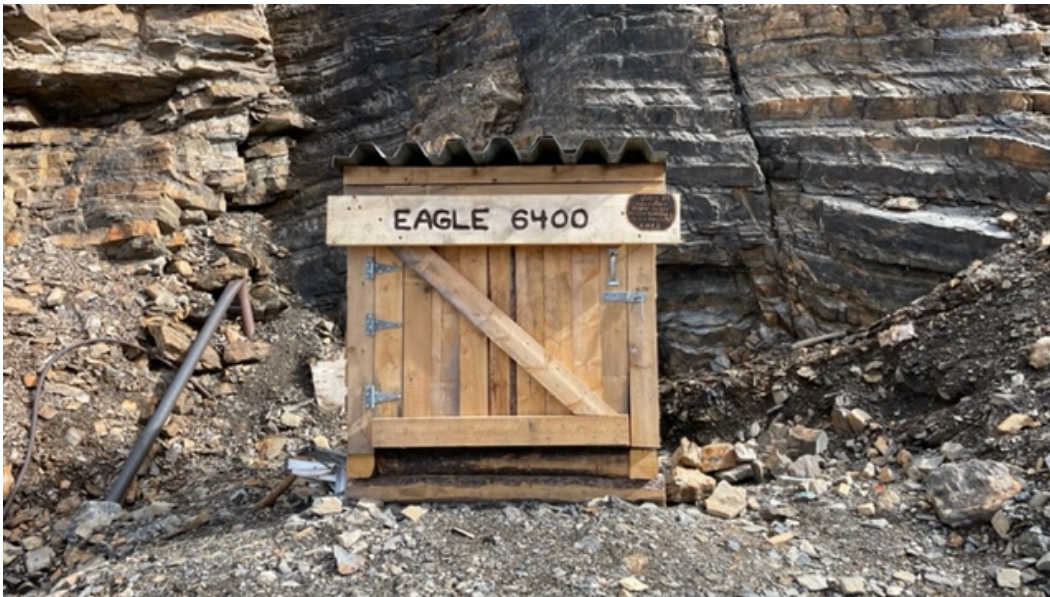
Photo 7- Final door installed on Davis Keays 6400 level.

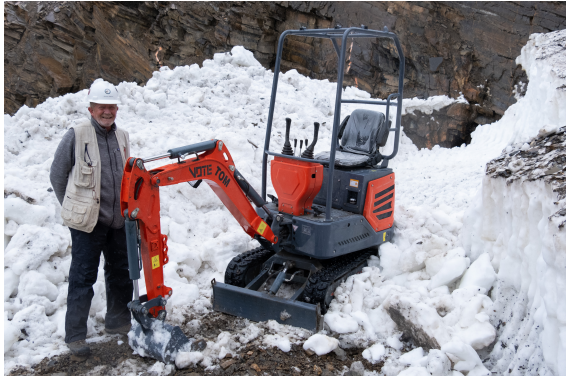
Photo 8 – Snow at Audit Entrance 5950 Level

The excavator was then slung by a 205 helicopter to the Davis Keays 5950 level at a lower elevation and the same process was performed. See Photo's 8-11 below.

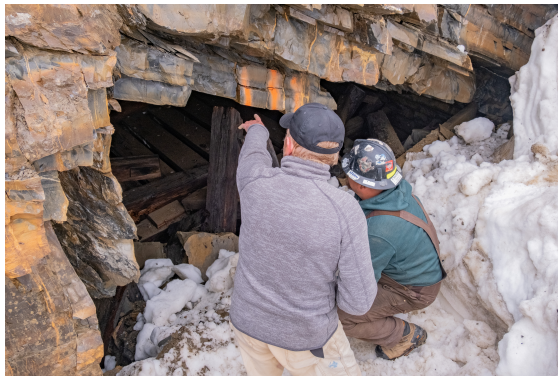
Photo 9 – Back / Roof Inspection of 5950 Level

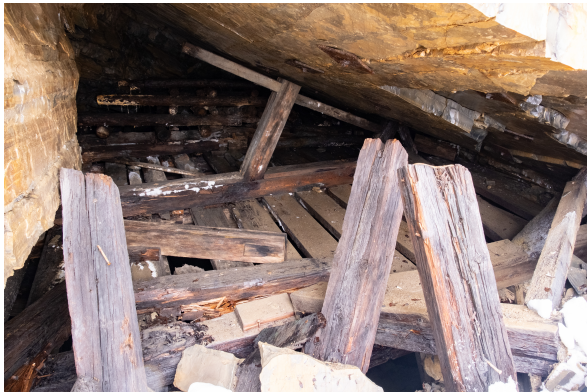
Photo 10 – Wood Timber Supporting the Roof / Back of the Adit Entrance

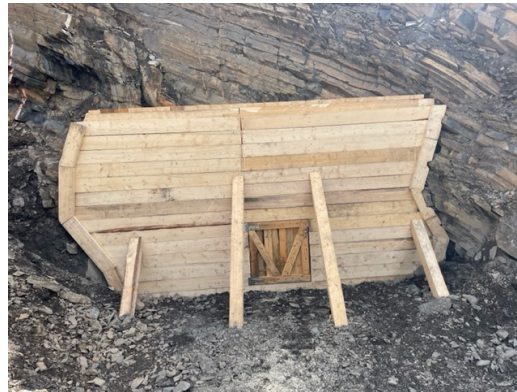
Photo 11 – Wooden Closure

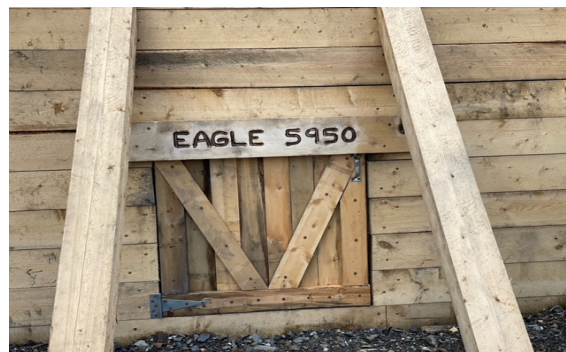
Photo 12 - Final door installed on Davis Keays 5950 level.

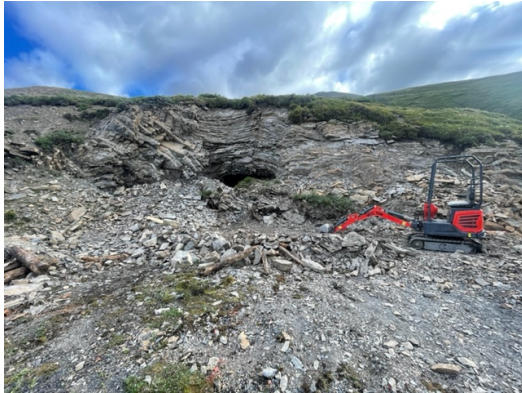
Photo 13 – 5800 Level Harris Vein Adit Before

The excavator was then moved by helicopter to the Harris Adit location and once again the same process was completed. See Photos 13 and 14 below.

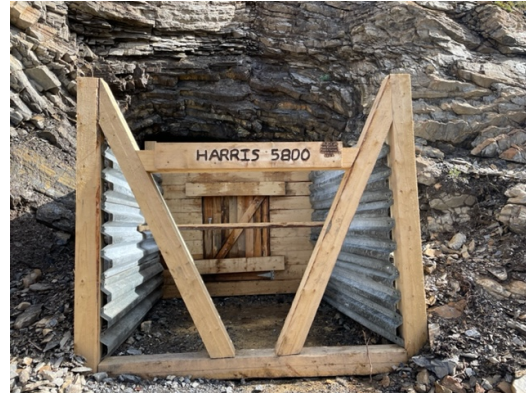
Photo 14 – 5800 Level Harris Vein Adit After

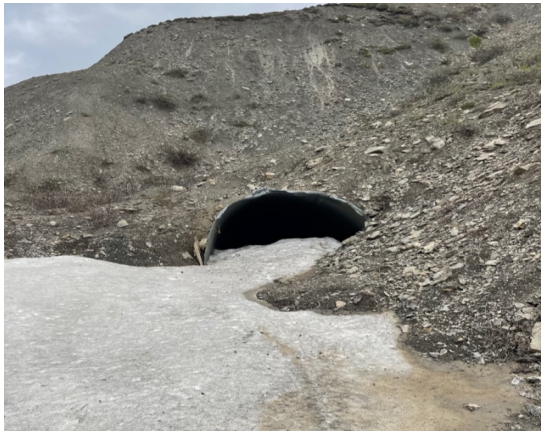
Photo 15 – 5200 Level Magnum Mine before

Once again, the excavator was move by helicopter to the Magnum Mine 5200 level adit and the same procedure was done once again. See Photos 15 and 16 below.

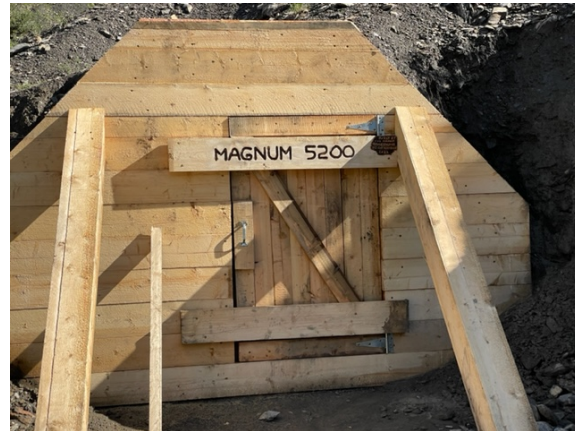
Photo 16 – 5200 level magnum Mine After
